Water Compliance Inspection Report

Name and Location of Facility Inspected (For industrial users discharging to POTW, also include POTW name and NPDES permit number) Hecla Ltd. Lucky Friday Mine and Mill 397 Friday Avenue Mullan, ID 83846	Entry Time/Date 8:00 am / 05/18/15	Permit Effective Date 12/01/2006
	Exit Time/Date 12:05 pm / 05/19/15	Permit Expiration Date 09/14/2008; admn extnd
Name(s) of On-Site Representative(s)/Title(s)/Phone and Fax Number(s) Bradley Kucera, P.E., Environmental Manager 208-744-1751, ext. 2349 (w); 208-661-5247 (m) BKucera@hecla-mining.com	Other Facility Data (e.g., SIC NAICS, and other descriptive information) SIC Code 1044 NAICS Code # 212222	
Name, Address of Responsible Official/Title/Phone and Fax Number Clayr Alexander, VP and General Manager Hecla Ltd., Lucky Friday Mine and Mill P.O. Box 31, Mullan, ID 83846 1-208-74401751, ext. 2304	Clayr Alexander replaces former Mine Manager Ed Sutich (I verified that this is the correct spelling for Mr. Alexander). Though I did not contact Mr. Alexander personally, he was aware of our presence at the mine. <div style="text-align: center;"> Contacted <input type="checkbox"/> Yes <input checked="" type="checkb

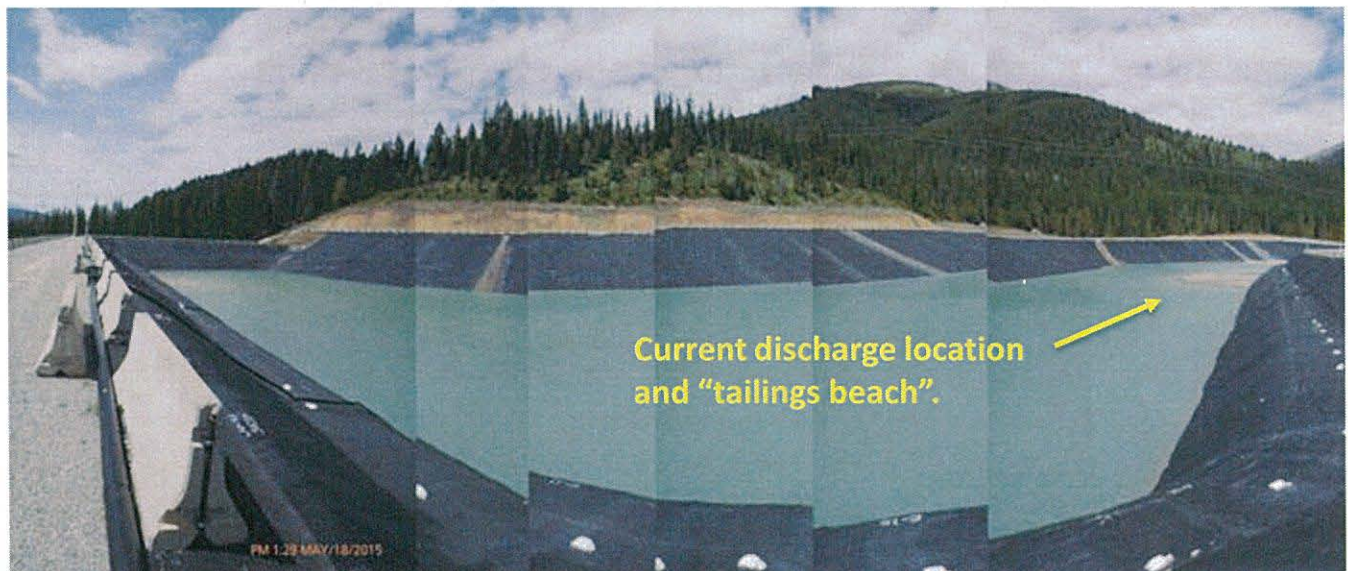
Photo No. 10 (P1010190-P1010196)

Facing northeast – looking back toward the location where the previous photo (Photo 9) was made.

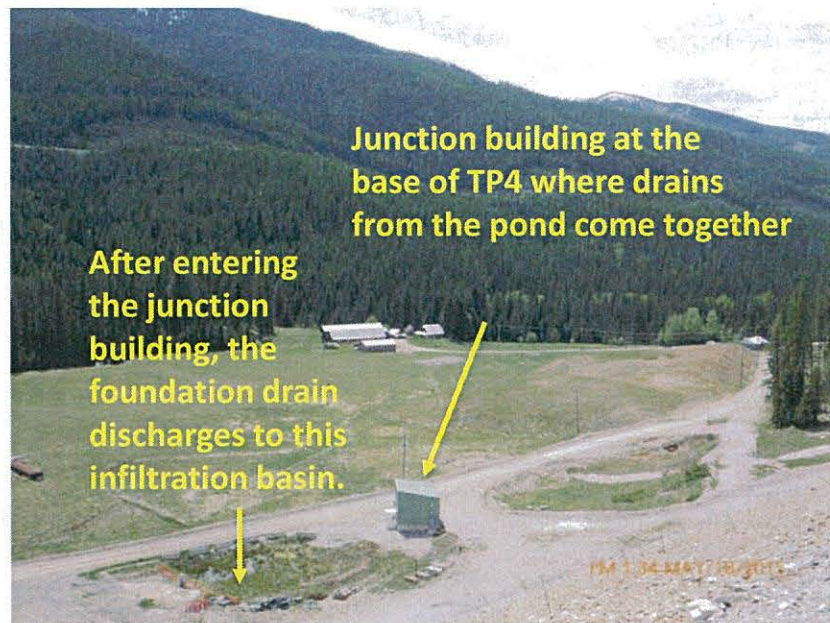
Photo No. 12 (P1010199)
Facing southwest from the top of Tailings Pond 4.

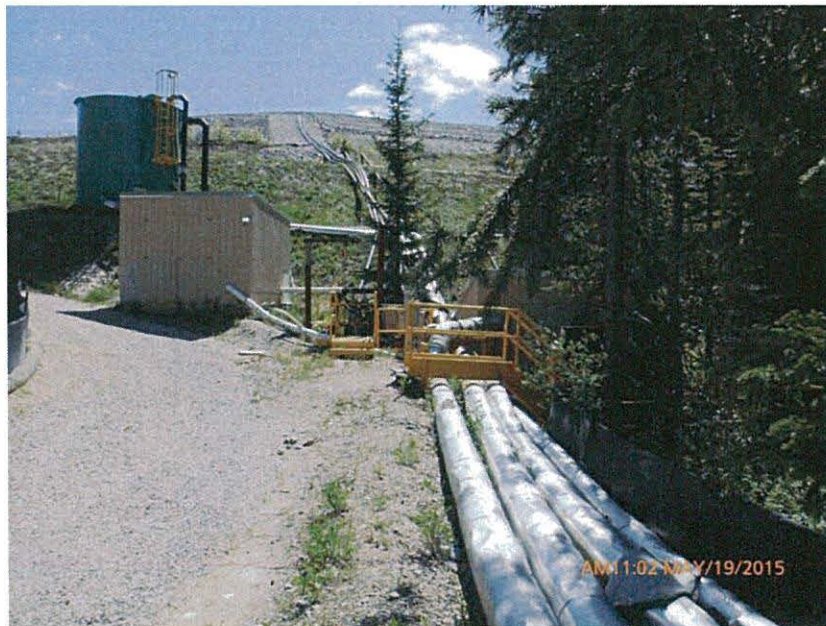
Photo No. 17 (P1010247)

Facing east – these are the lines that convey water from the top of TP3 to WWTP3.

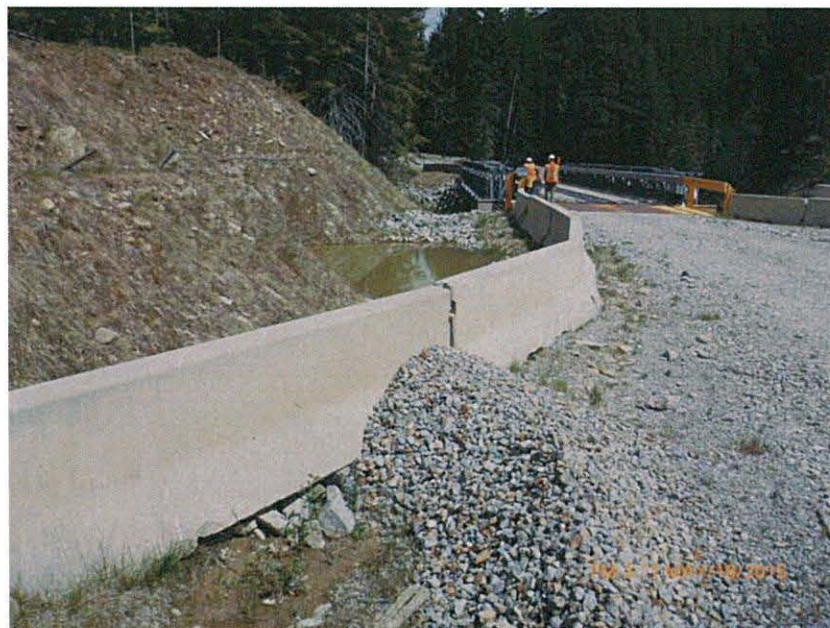
Photo No. 21 (P1010207)

Facing east – this access road across the LNF to the borrow source was constructed during the development of TP4.

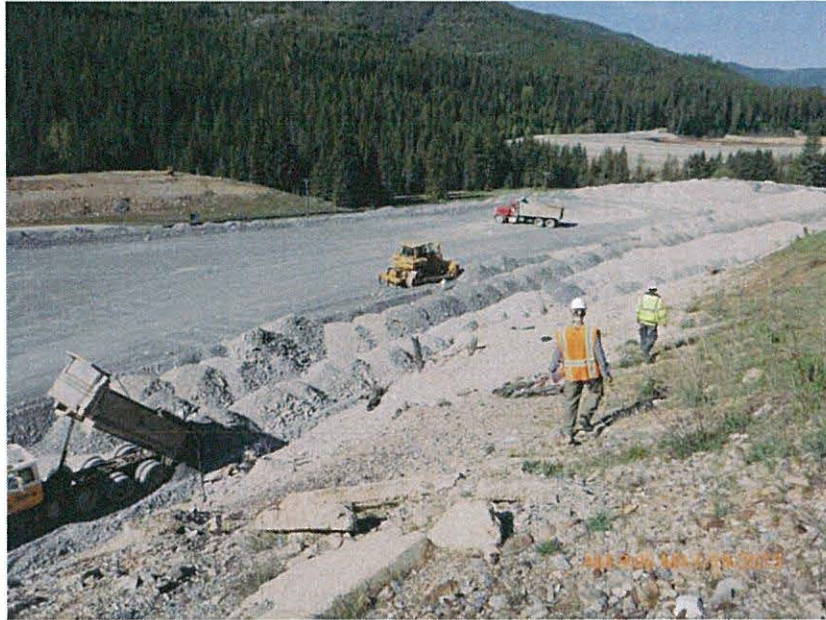
Photo No. 26 (P1010229)

Facing southwest from above the Silver Mountain Dump – the coarsely ground rock from the mill operations is accumulated in this area. This material will reportedly be used to construct the next stage at TP4

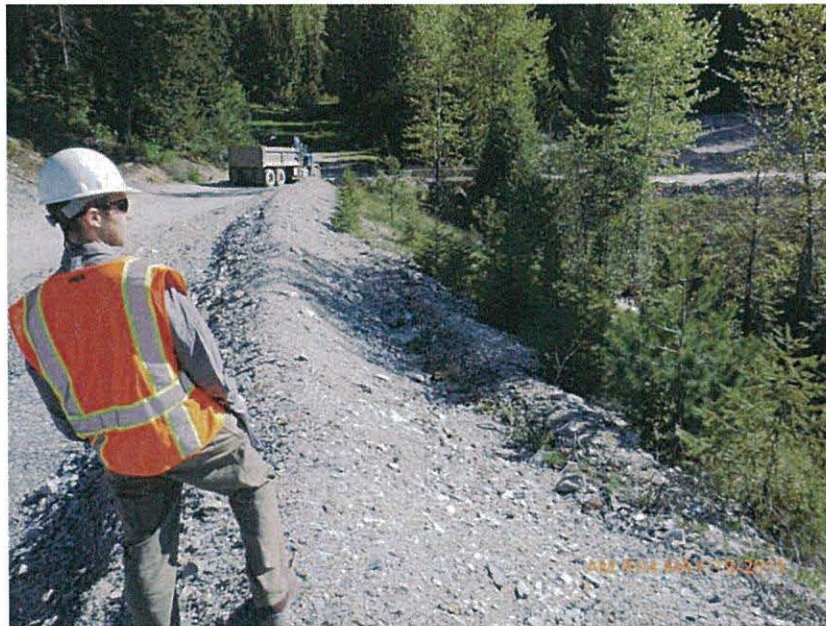
Photo No. 27 (P1010230)

Facing northeast – this photo was made from the crest of the berm that separates the Silver Mountain Dump from Daisy Creek. After the curve at the NE end of the berm, the road descends gradually for approximately 700 feet to its intersection with Larson Road.

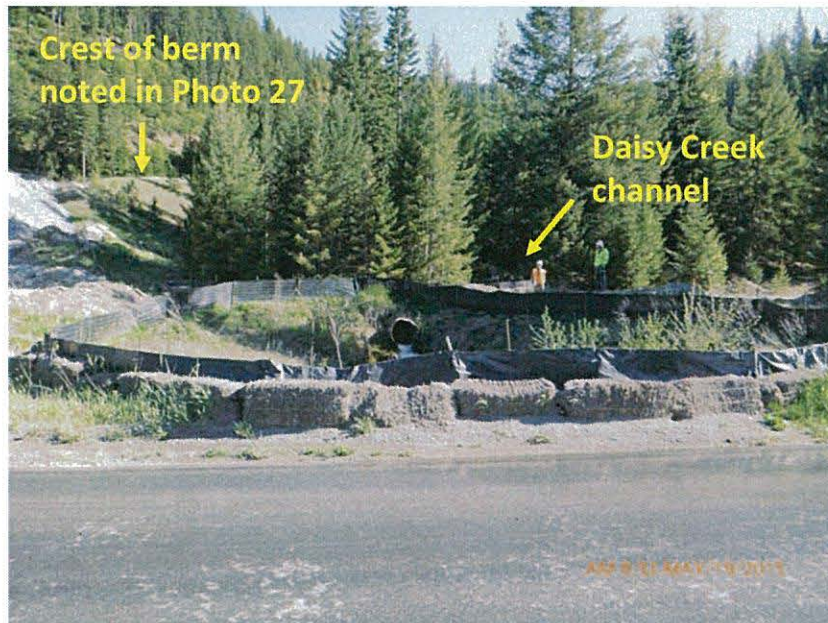
Photo No. 28 (P1010221)

Facing north – Daisy Creek flows into this shallow plunge pool before passing through culvert under Larson Road. From there, it flows approximately 845' to its confluence with SFCdA.

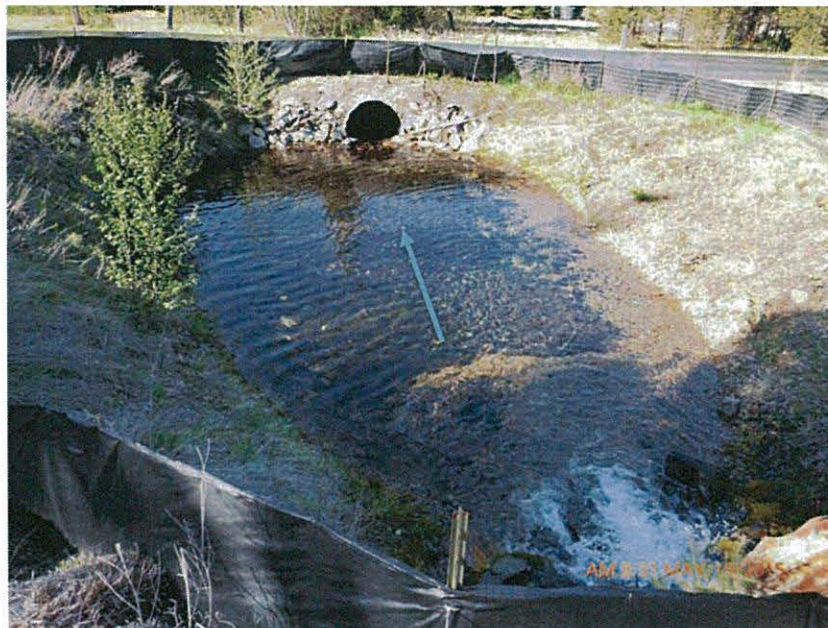
Photo No. 29 (P1010220)

Facing south – Daisy Creek flows through this plunge pool, through the culvert under Larson Road, to its confluence with SFCdA.
